**COUNTY ENGINEERS ASSOCIATION OF MARYLAND  
SPRING 2016 CONFERENCE**

# Two bridges in Two Months - Accelerated Bridge Construction (ABC)

## Montgomery County DOT's approach to solving critical challenges on the Whites Ferry Road Bridges Project

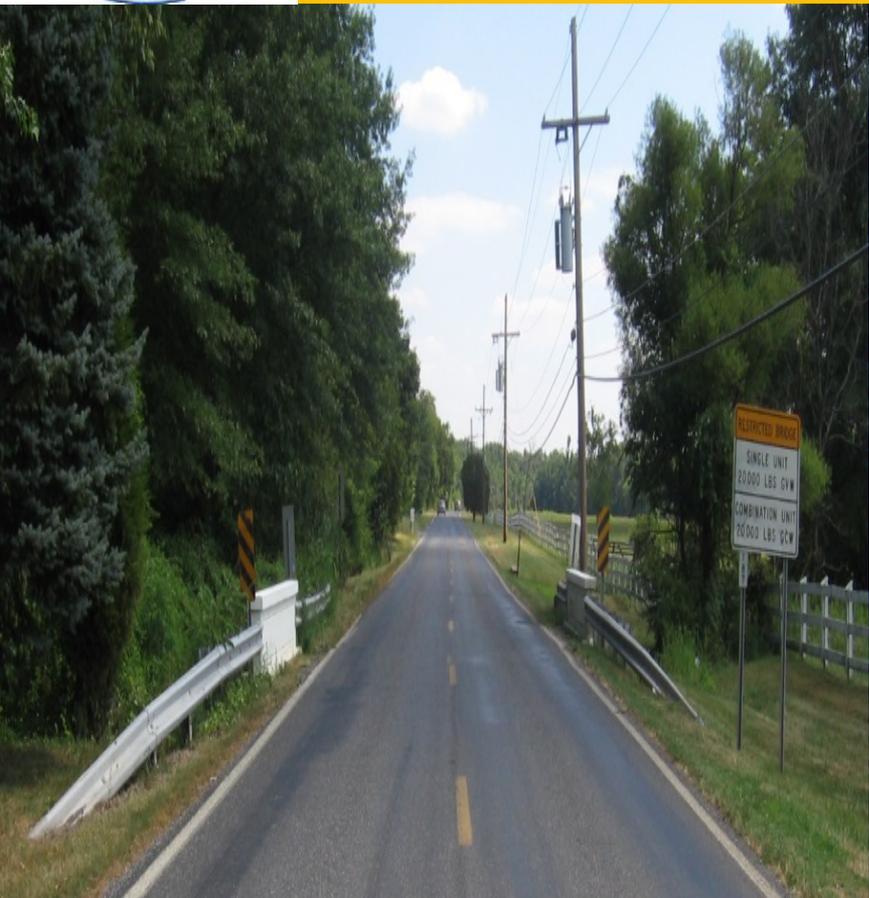
- Whites Ferry Road - designated as a county arterial road.
- Bridges located just outside Poolesville
- Bridge No. M-0187B is located approximately 0.3 miles southeast of the intersection of Waesche Road and Whites Ferry Road
- Bridge No. M-0189B located approximately 1.3 miles southeast of the intersection of Waesche Road and Whites Ferry Road.
- The existing single cell culvert is approximately 275 feet northeast of Bridge No. M-0189B and is downstream from the existing bridge.

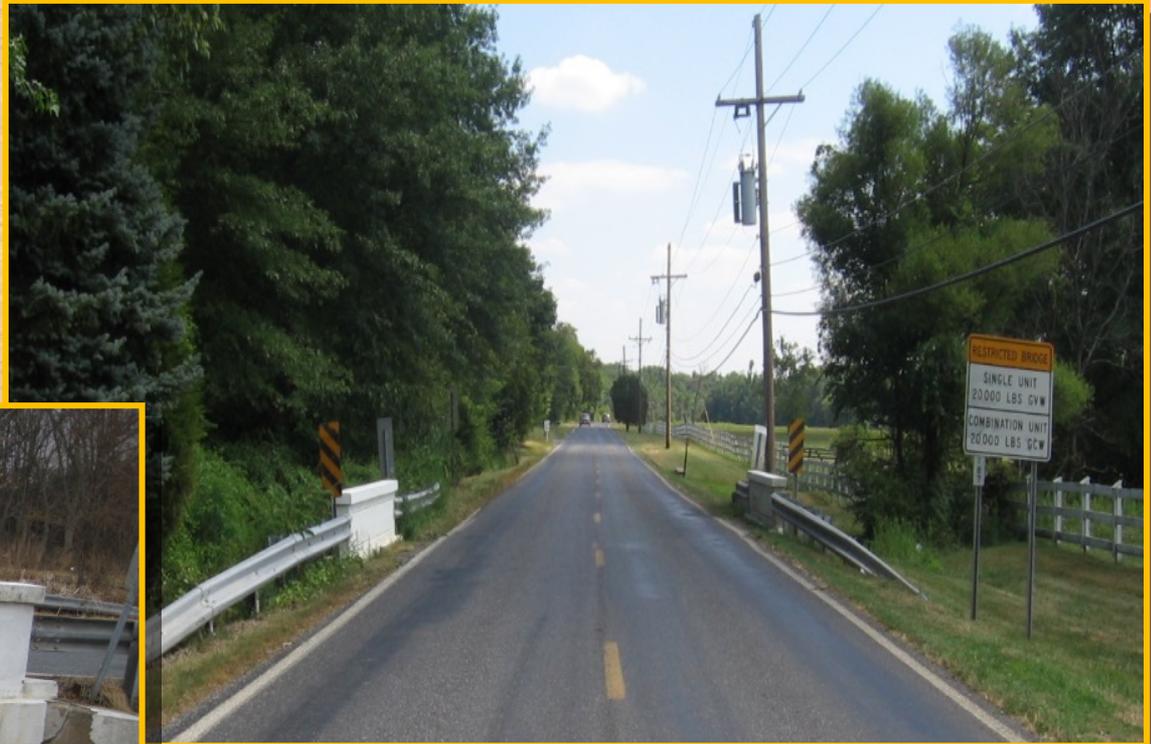
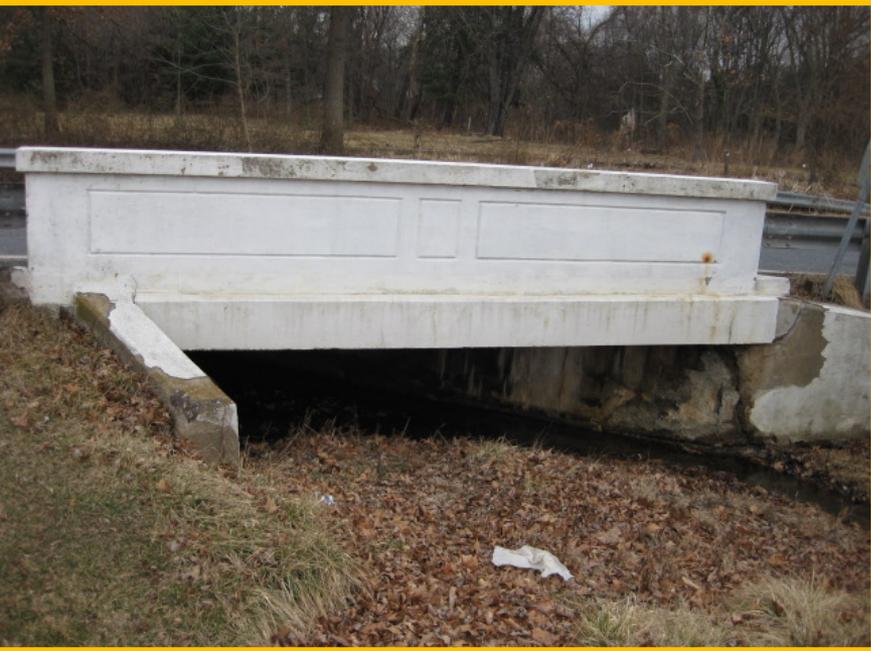
Existing Bridge M-187B

- Built in 1920
- 16-foot long single span
- 24'-4" clear roadway

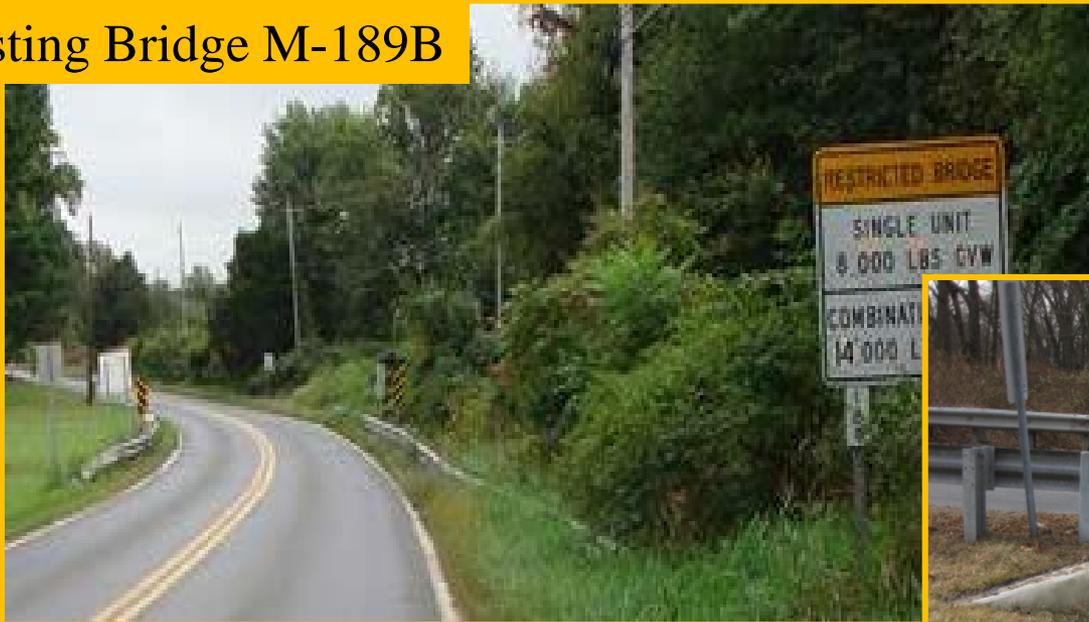
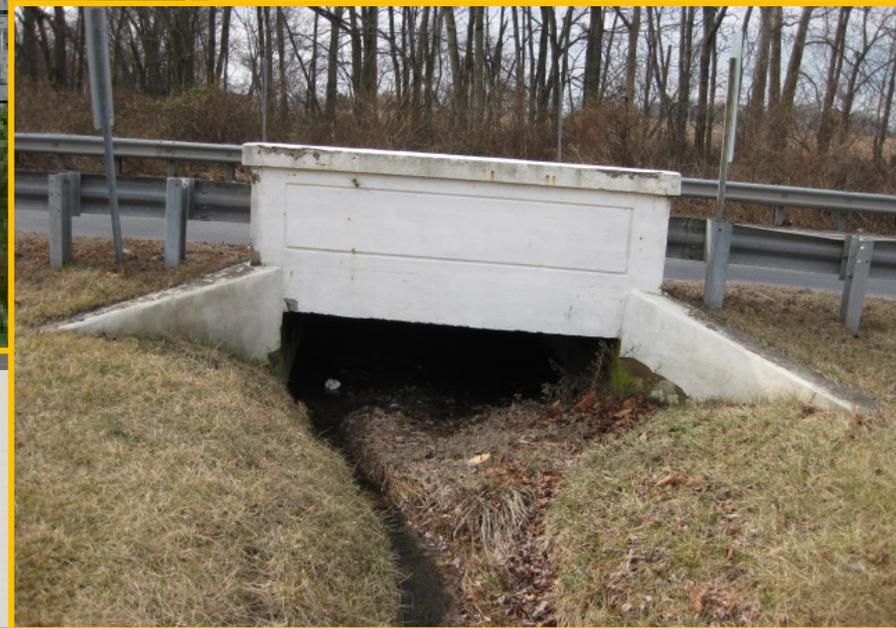
## Existing Bridge M-189B

- Built in 1920
- 10-foot long single span
- 23'-8" clear roadway

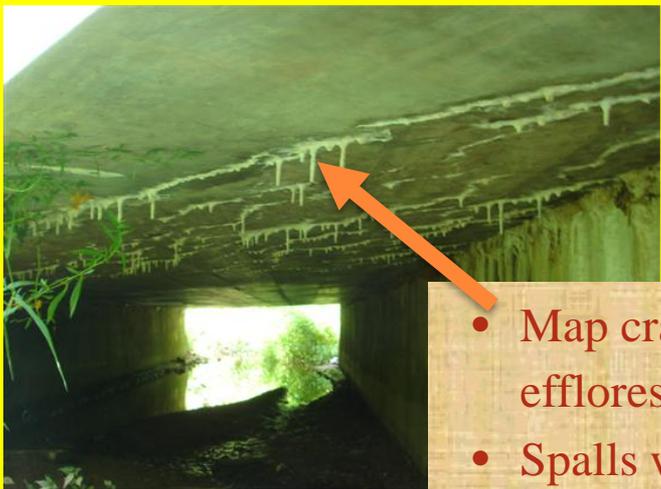
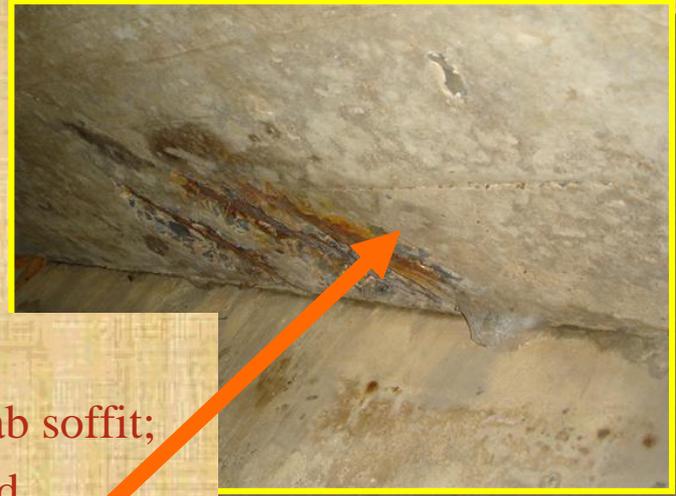
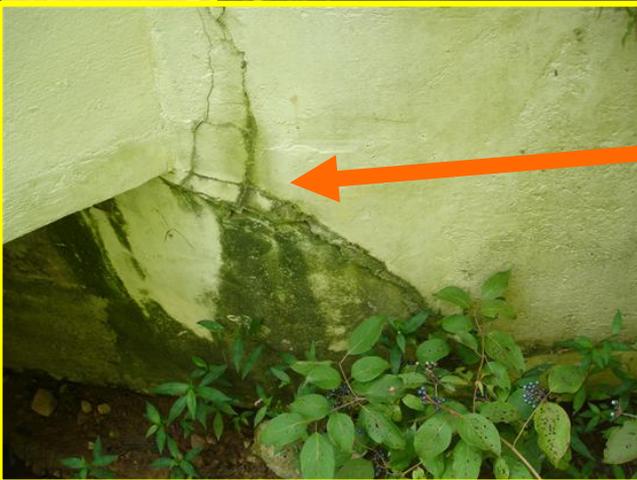
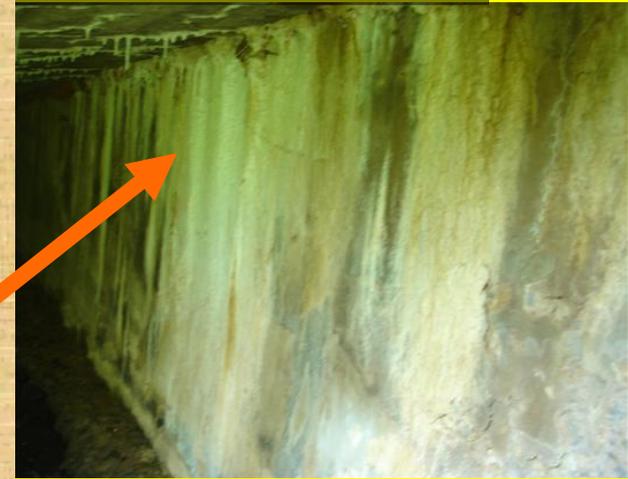
## Existing Bridge M-187B structural defects

- Map cracking with efflorescence in slab soffit;
- Spalls with exposed reinforcing in slab soffit
- Vertical crack at joint of west abutment and northwest wing wall
- Heavy efflorescence at the south end of the east abutment

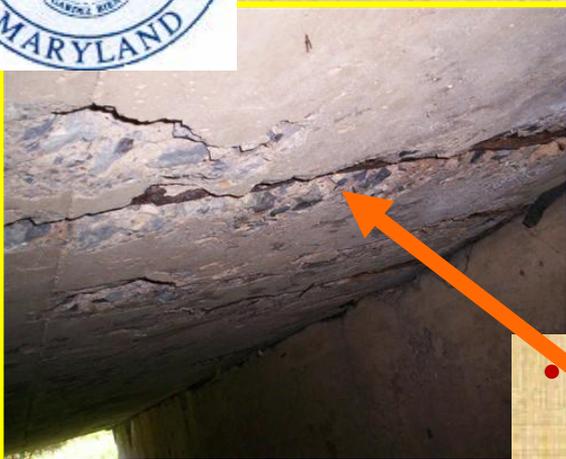
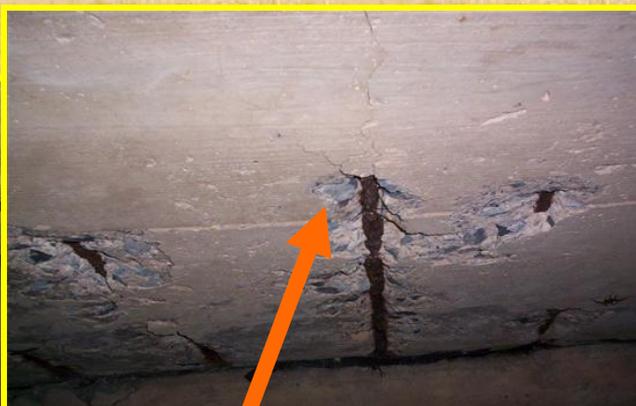
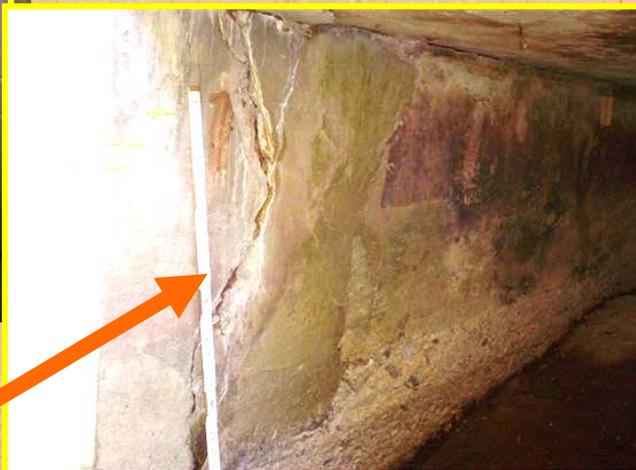
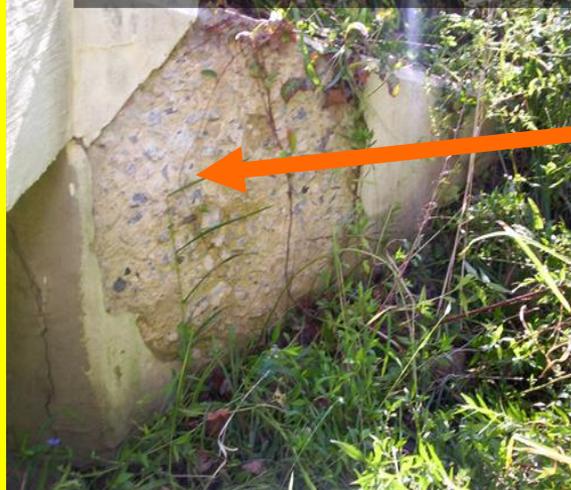
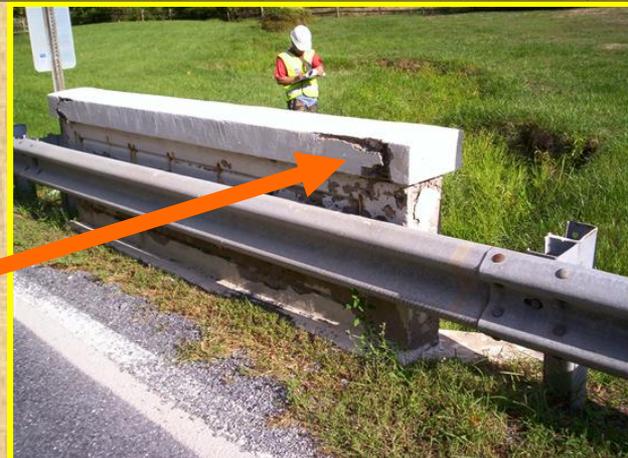
Existing Bridge M-189B  
structural defects

- Spalls in the soffit with exposed and corroded reinforcement,
- Full height crack in west abutment,
- Crack and spall in the west abutment,
- Spall in southeast wingwall,
- Spall in the east abutment, does not meet FHWA Safety Standards,
- Spalling on east and west end of north railing

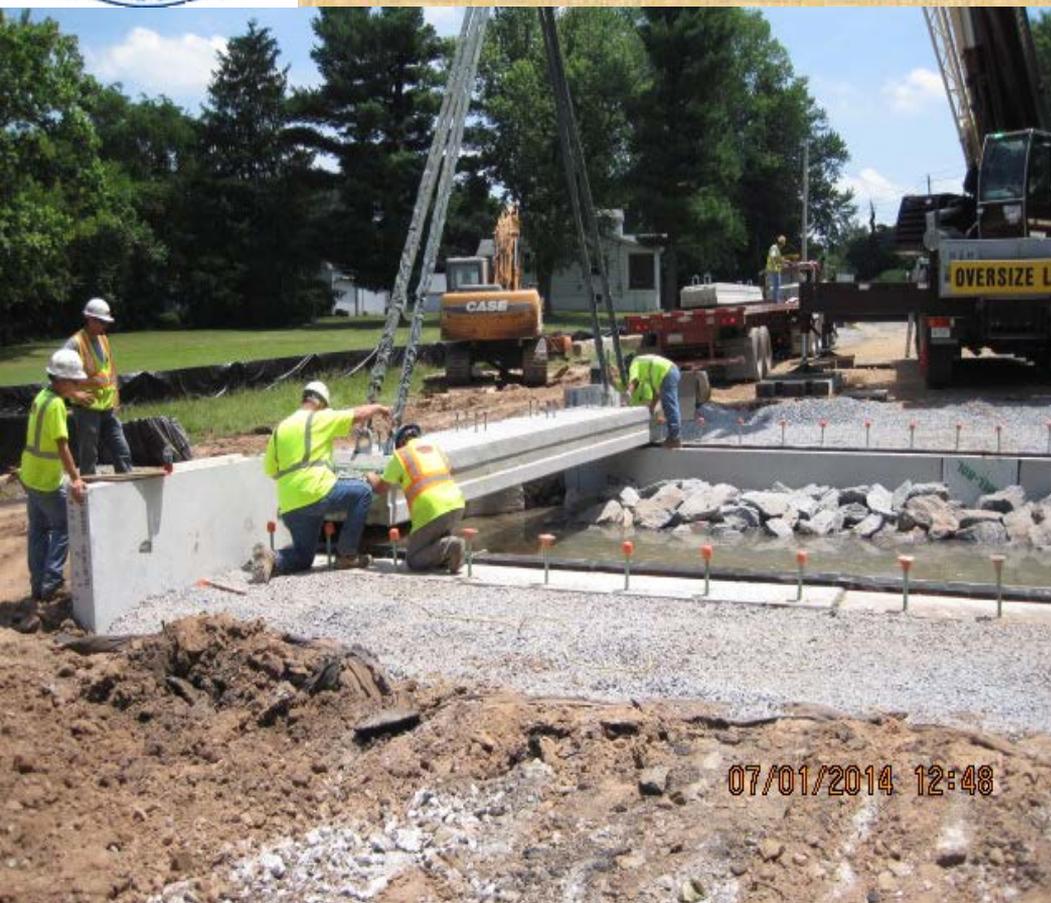
## Existing Bridge M-187B

- ❖ Existing vertical profile and horizontal alignments were maintained
- ❖ New 46-foot-span bridge
  - ❖ Solid, precast, pre-stressed concrete beams
  - ❖ Cast in place deck overlay
  - ❖ Beams supported on new RC caps with steel H-piles.
  - ❖ Bridge was widened to 30-foot clear roadway (2X11'+2X4')
  - ❖ Safe on-road bicycling - in accordance with the Master Plan
  - ❖ Removed Load restrictions

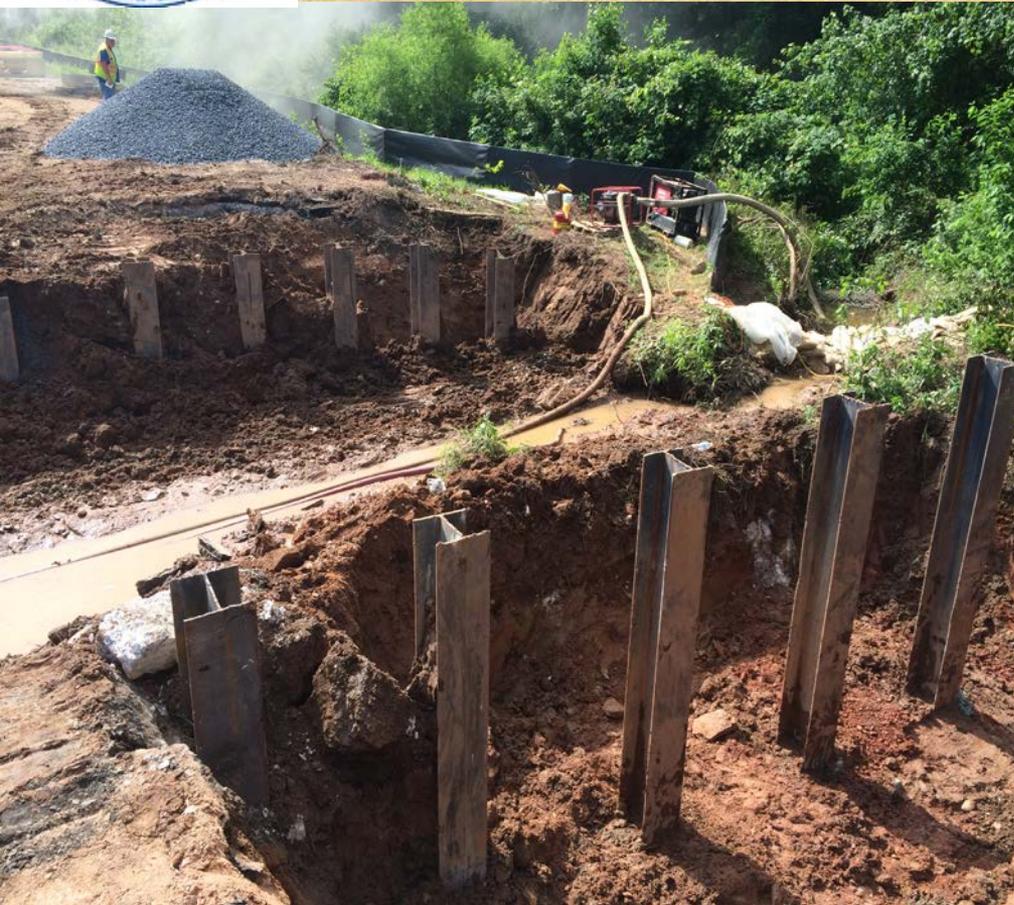
## Existing Bridge M-189B

- ❖ Existing horizontal alignment was maintained
- ❖ Vertical profile was raised by app. 1 foot at the bridge to reduce the likelihood of flooding
- ❖ New 24-foot-span bridge
  - ❖ Solid, precast, pre-stressed concrete beams
  - ❖ Cast in place deck overlay
  - ❖ Beams supported on new RC caps with steel H-piles.
  - ❖ Bridge was widened to 30-foot clear roadway (2X11'+2X4')
  - ❖ Safe on-road bicycling - in accordance with the Master Plan.
  - ❖ Replaced railing
  - ❖ Removed Load restrictions

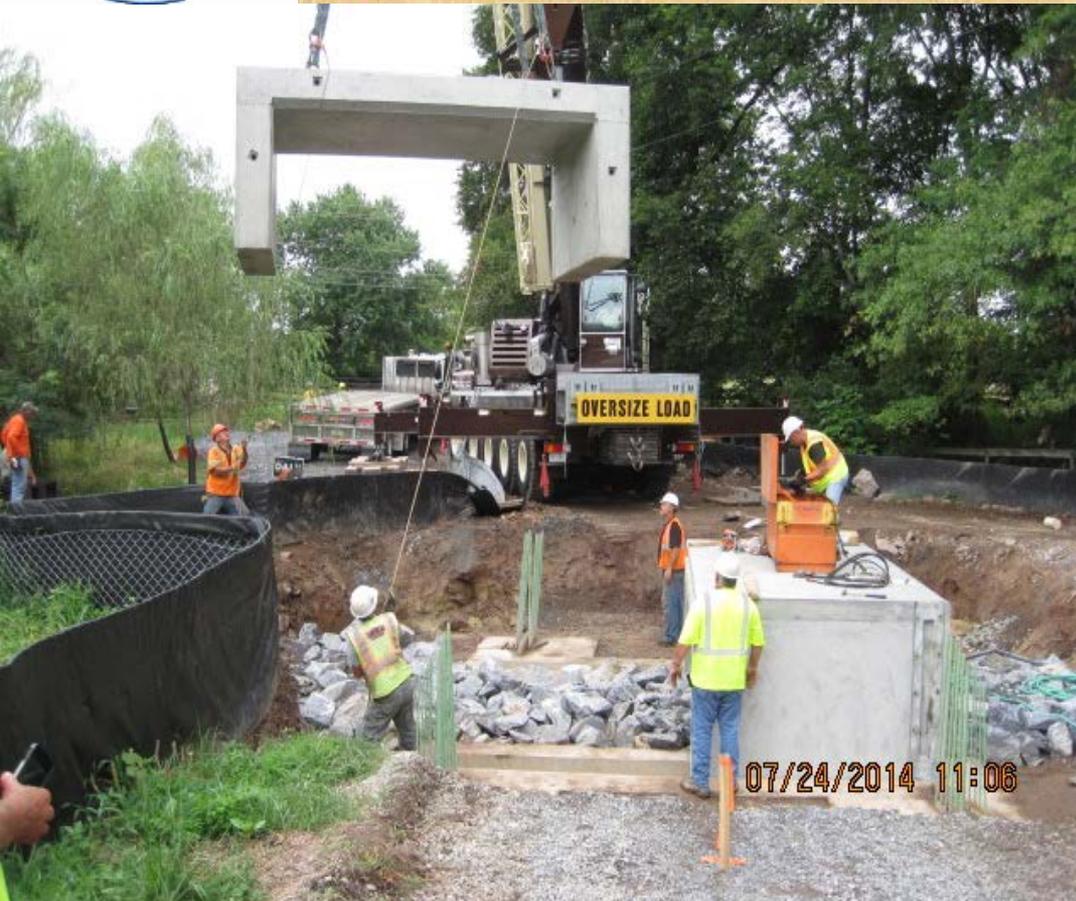
Culvert Near Bridge M-189B

- ❖ Existing - 4-foot clear opening
- ❖ Proposed – 11'-6" clear opening
- ❖ Driveway/Access road reconstructed to match new width and road grade
- ❖ Work included providing temporary ped bridge for home owners

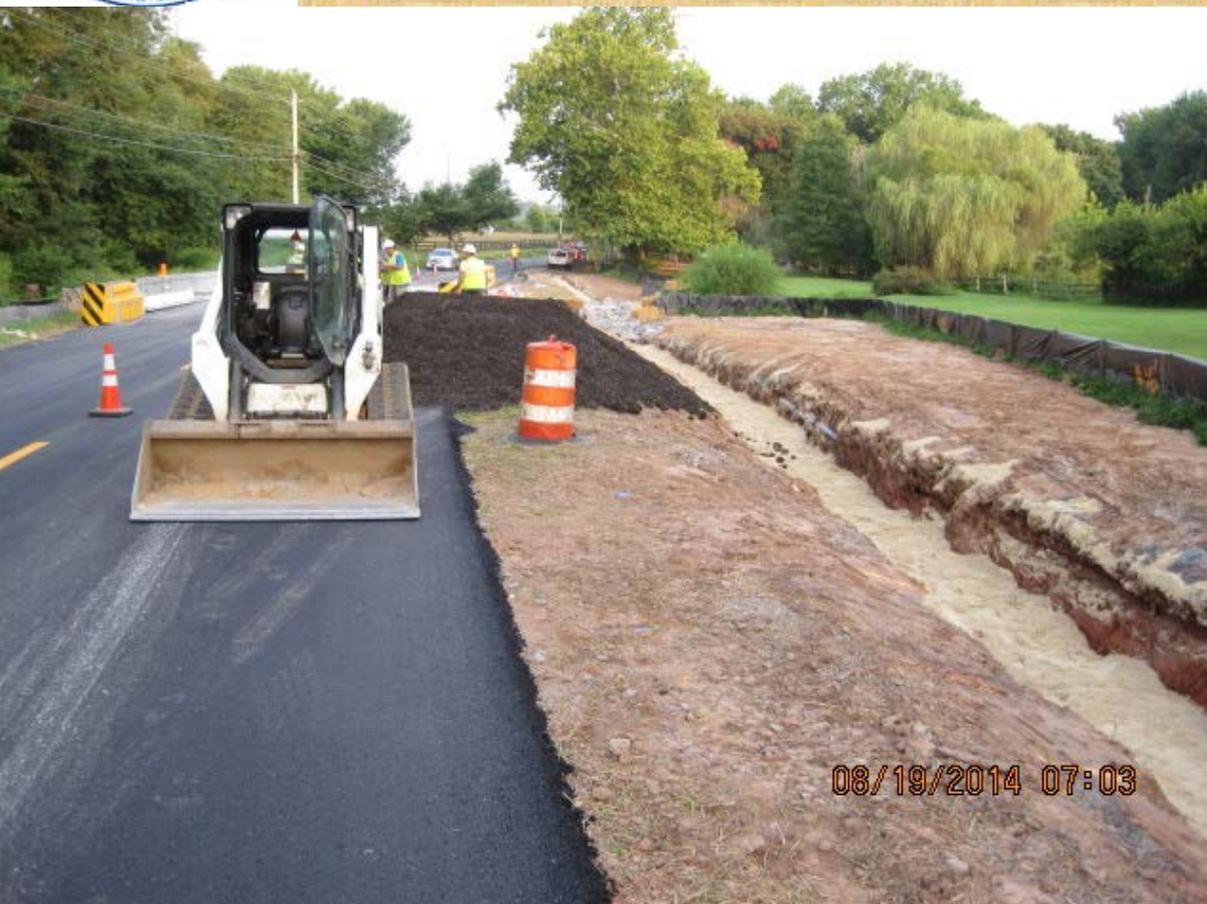
## SWM Facilities

- ❖ Bio-swales were constructed alongside both bridges
- ❖ Addressed additional impervious area
- ❖ Constructed as the last item on the project
- ❖ Additional landscaping

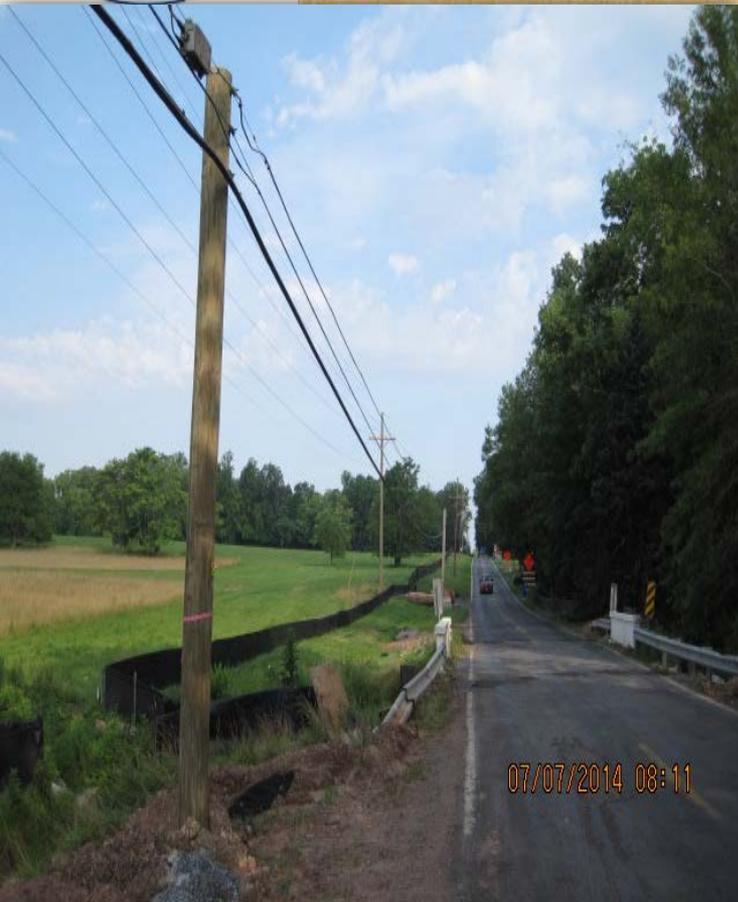
## ➤ Utility relocations:

- Foot print of the roadway became wider
- Overhead utilities alongside the road had to be relocated.
- Despite MCDOT's relentless push for the timely relocation of utilities, **communication lines remained in place**
- In order to meet the project timeline and avoid further damage to these bridges, **MCDOT allowed work to start while aggressively pushing for the relocation of the utilities**
- After review of the site conditions with the Contractor (Charles J Merlo) it was determined that **at bridge 189B the relocation was not needed and the Contractor could proceed while using caution during grading.**

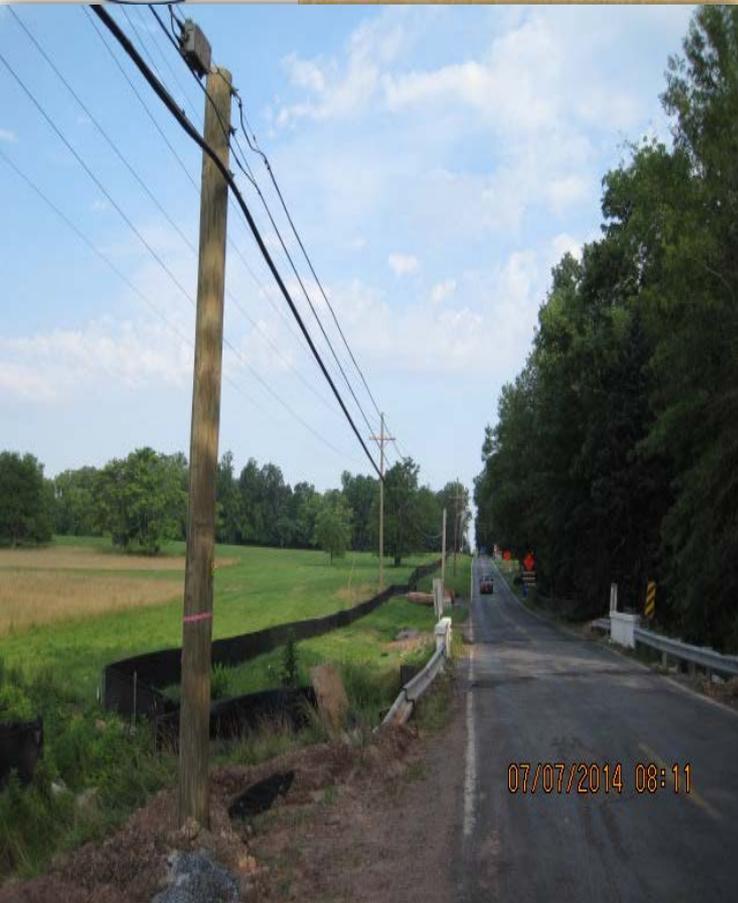
## ➤ **Utility relocations (Continued):**

- At the 187B bridge, the **electrical overhead lines were relocated** to their final location but the poles remained in place with the communication lines.
- Since the top of the poles were cut to a reasonable height, the Contractor again was able to complete their work near but not in conflict with the **Verizon and Comcast lines** still in place.
- The contractor had to **maneuver his equipment surgically in order to avoid damaging these lines**. With close coordination and tact, the bridge elements were installed without damaging any of the utility lines.

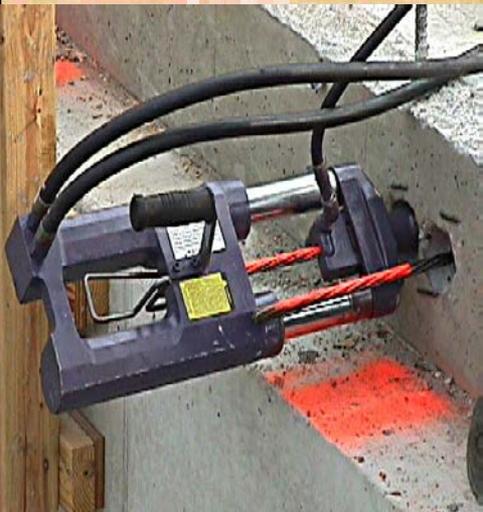
### ➤ **Change in design requirements (Post-tensioning):**

- The slab beams were designed with an old post-tensioning requirement that specified a post tensioning force of 120 kips applied once just prior to grouting the rod holes.
- In the midst of construction, during the shop drawing process, a new directive was issued for a two-step post-tensioning process. This caused some minor delays and confusion during construction.
- MCDOT also had to pay the Contractor additional money due to the fact that the post-tensioning (Sub Contractor) had to visit the site on multiple occasions to complete the tensioning.
