2026 Spring Conference at Wisp Resort
McHenry, Maryland

Safe, Economical, and Efficient Structure Assessments

Mark Wolcott, PE
Innovative Subsurface Evaluation & Engineering, LLC (iSee)

May 8, 2026

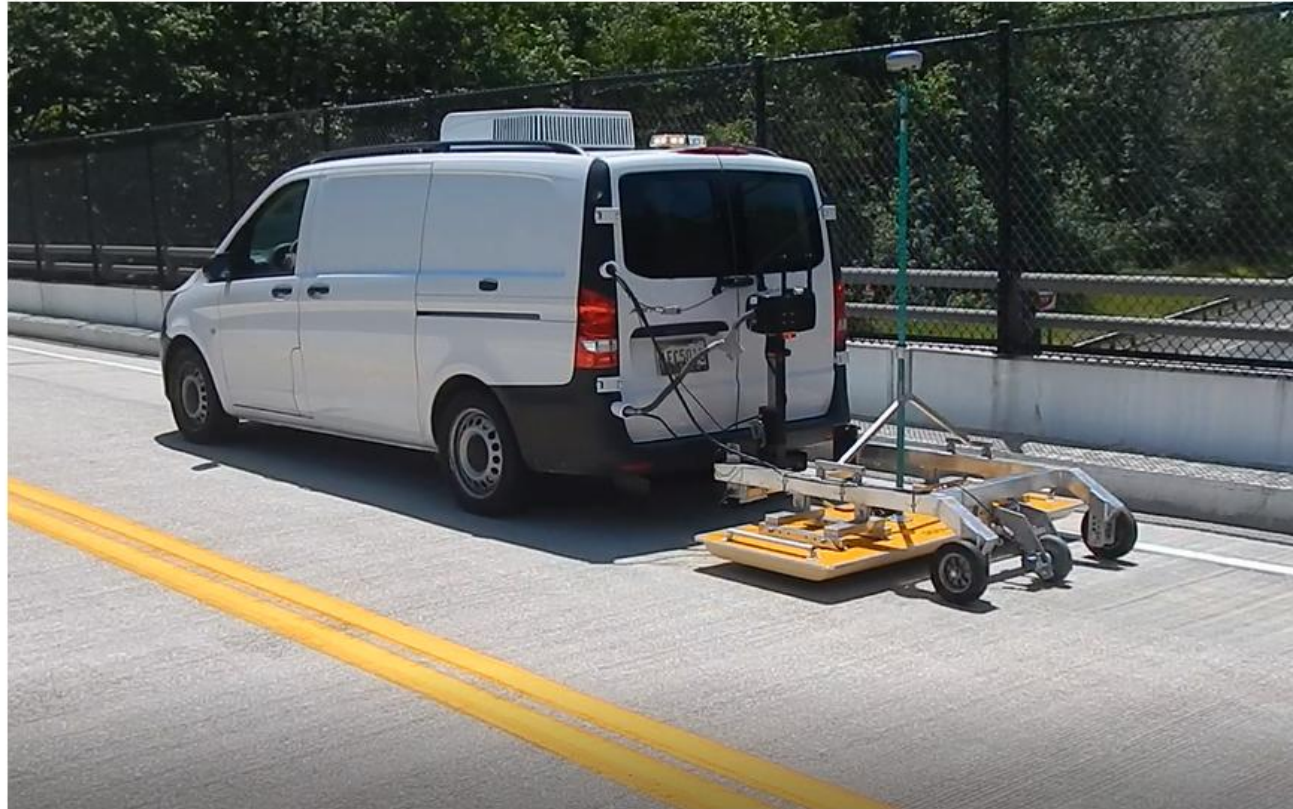
3D-GPR Data Collection – Safe and Efficient (No Lane Closures – Moving Operation)

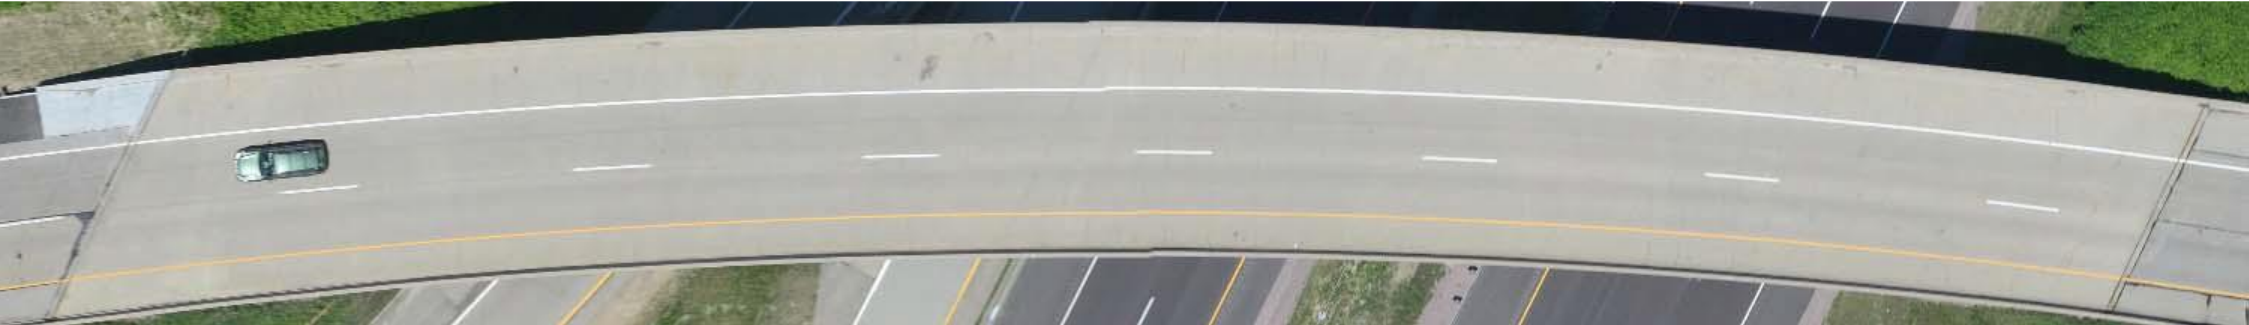
DECK IN GOOD CONDITION

Visual

Infrared

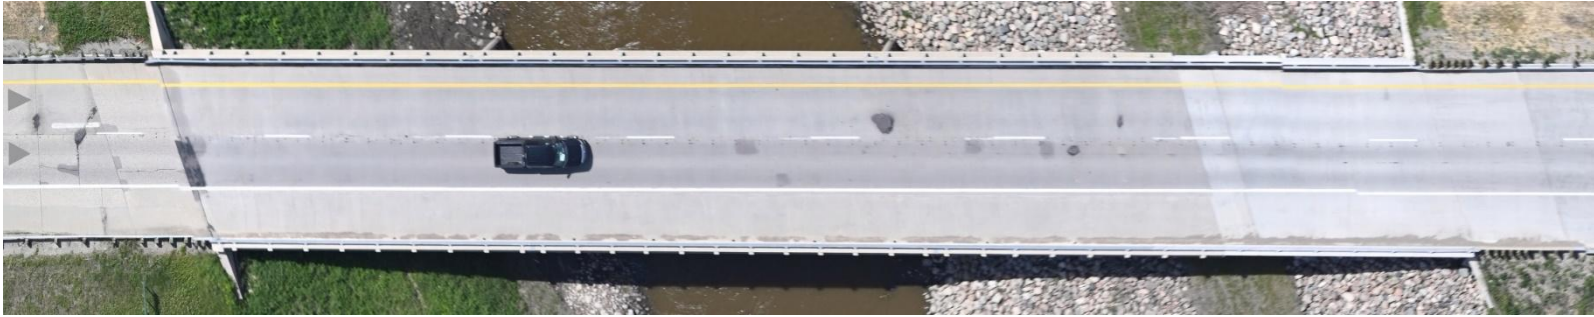
MAPPED RESULTS

Condition	Map Legend	Quantity (sf)	Quantity (%)
Delamination	 	780	7.1%
Patching	 	62	0.6%
Spalling	 	0	0%

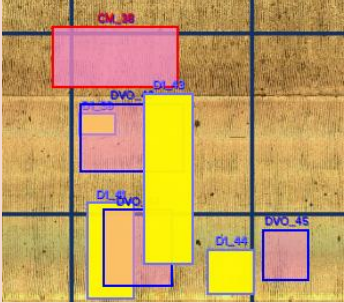
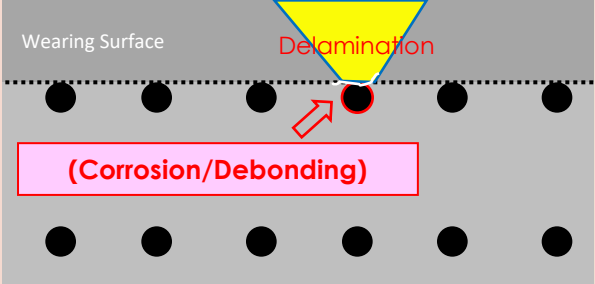
IRT & GPR results	Graphical description	Recommendation
<p>Case D1 Delamination with Corrosion/Debonding at top rebar</p>

<ul style="list-style-type: none"> ➤ Repair up to the rebar depth ➤ Corrosion protection for rebar (if necessary)
<p>Case D2 Delamination within the overlay layer</p>

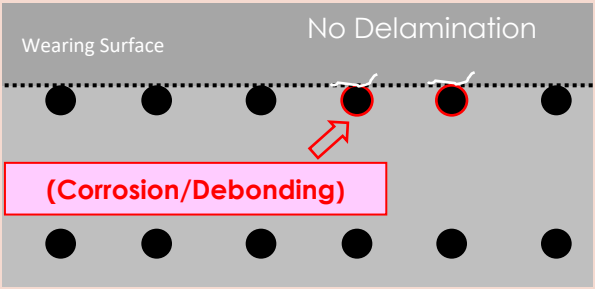
<ul style="list-style-type: none"> ➤ Repair within the overlay
<p>Case 3 Corrosion/Debonding at top rebar but no delamination yet</p>

<ul style="list-style-type: none"> ➤ For spot areas, monitoring every 2 years ➤ If it was a majority of the bridge deck, more immediate action

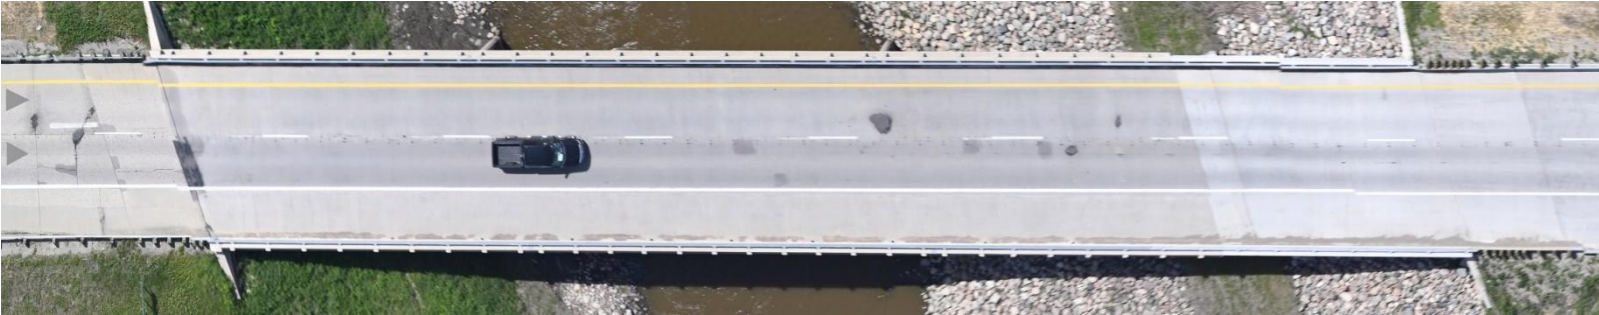
MAPPED RESULTS

Condition	Map Legend	Quantity (sf)	Quantity (%)
Delamination	 	780	7.1%
Patching	 	62	0.6%
Spalling	 	0	0%

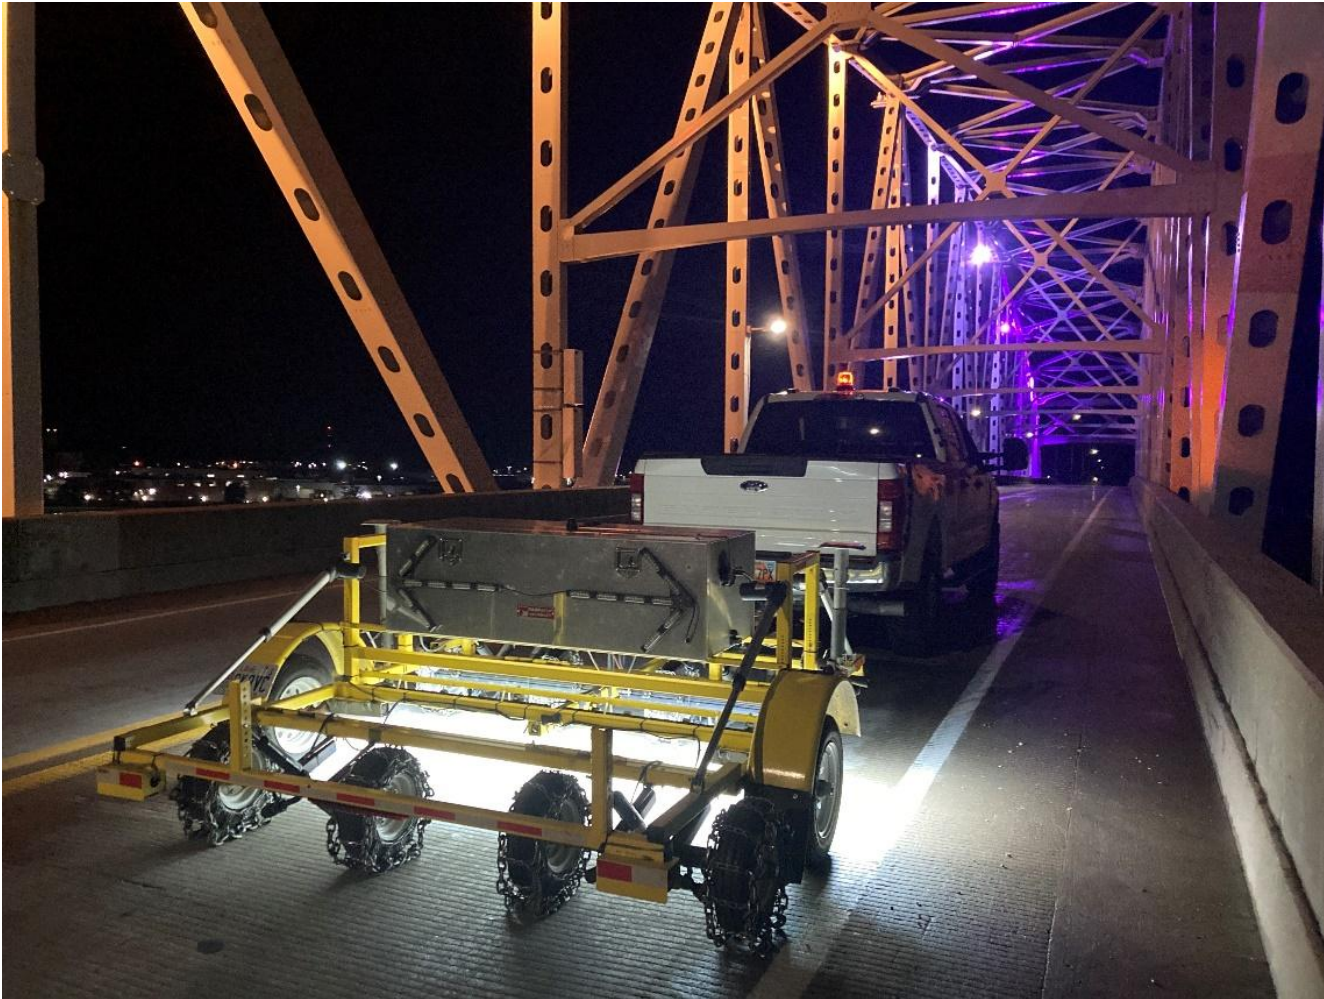
RAPID AUTOMATED SOUNDING (RAS) DATA COLLECTION

- Chain-affixed wheels impact the deck.
- Microphones record acoustic response to on-board computer.
- High-speed high-resolution cameras capture surface defects
- Data synchronized with GPS and surface imaging for precise location referencing.

- Chain drag or hammer sounding are widely used and commonly accepted techniques for delamination location
- RAS automates these methods with chains attached to wheels moving at ~20 MPH
 - Chain impacts are consistent
 - Removes subjectivity of manual chaining
 - Increases safety with all personnel remaining in vehicles
 - Inspections completed in minutes rather than hours

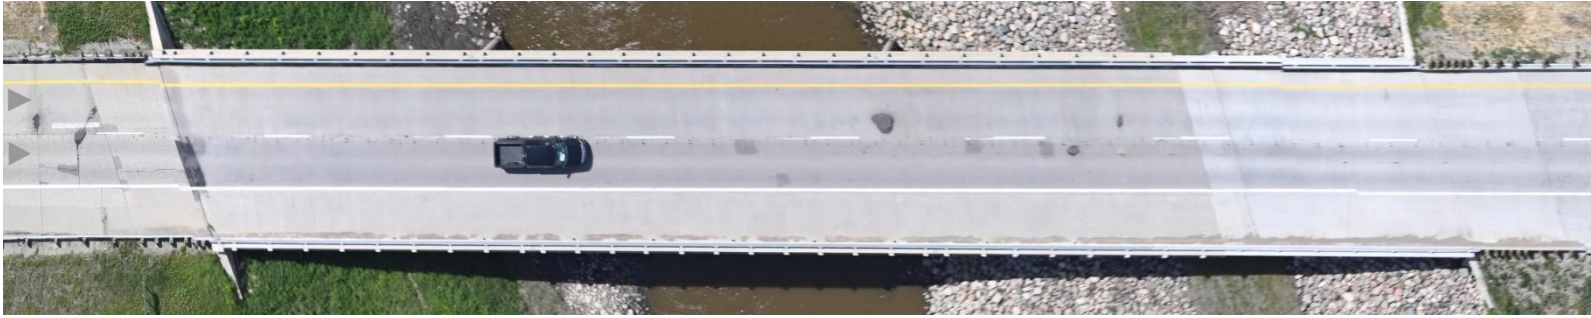
MAPPED RESULTS

Condition	Map Legend	Quantity (sf)	Quantity (%)
Delamination	 	780	7.1%
Patching

62	0.6%
Spalling	 	0	0%

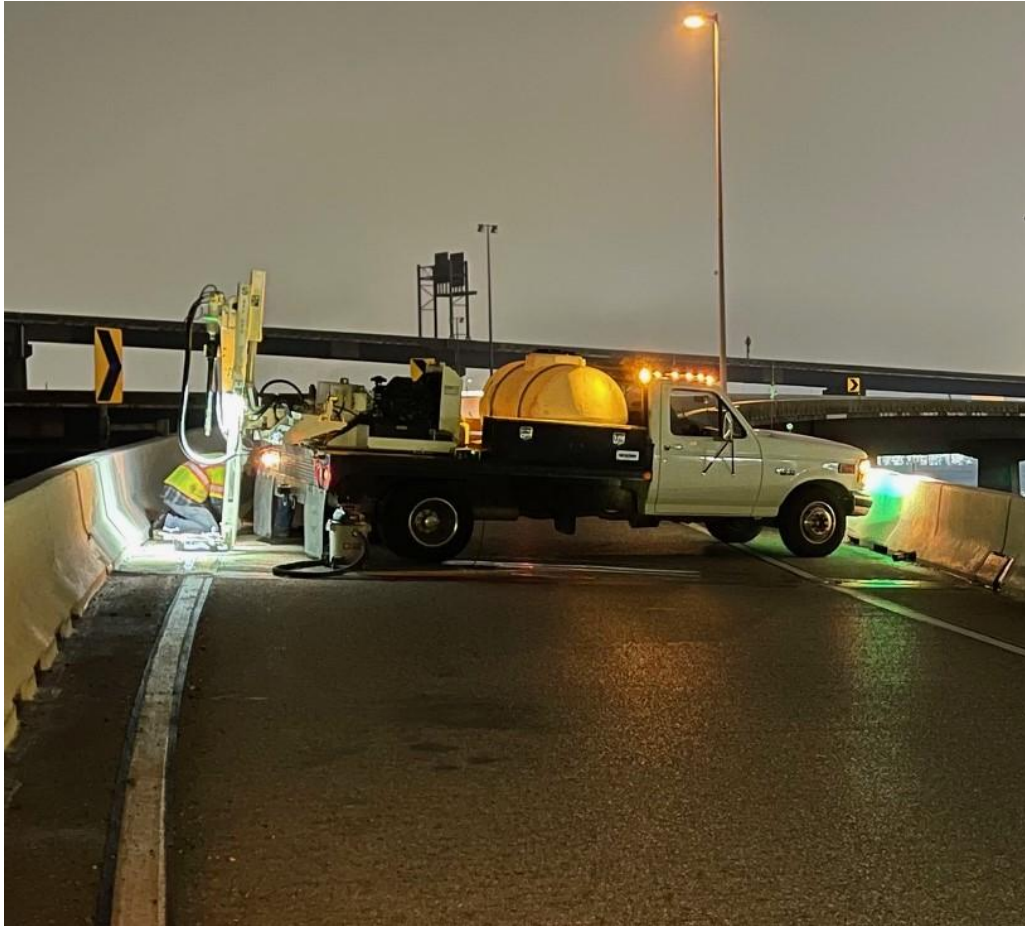
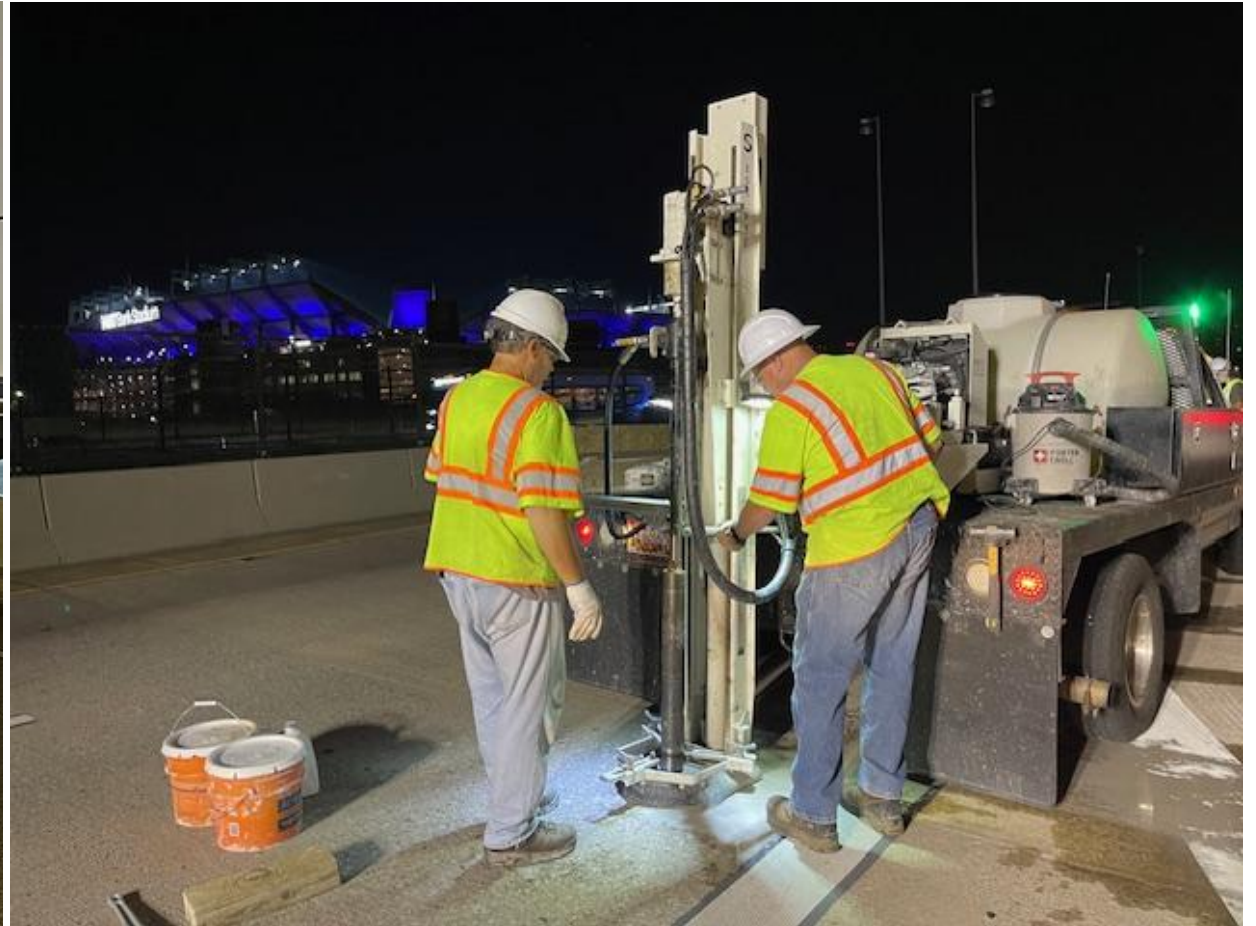
Bridge Deck Investigation Equipment

- Core Rig

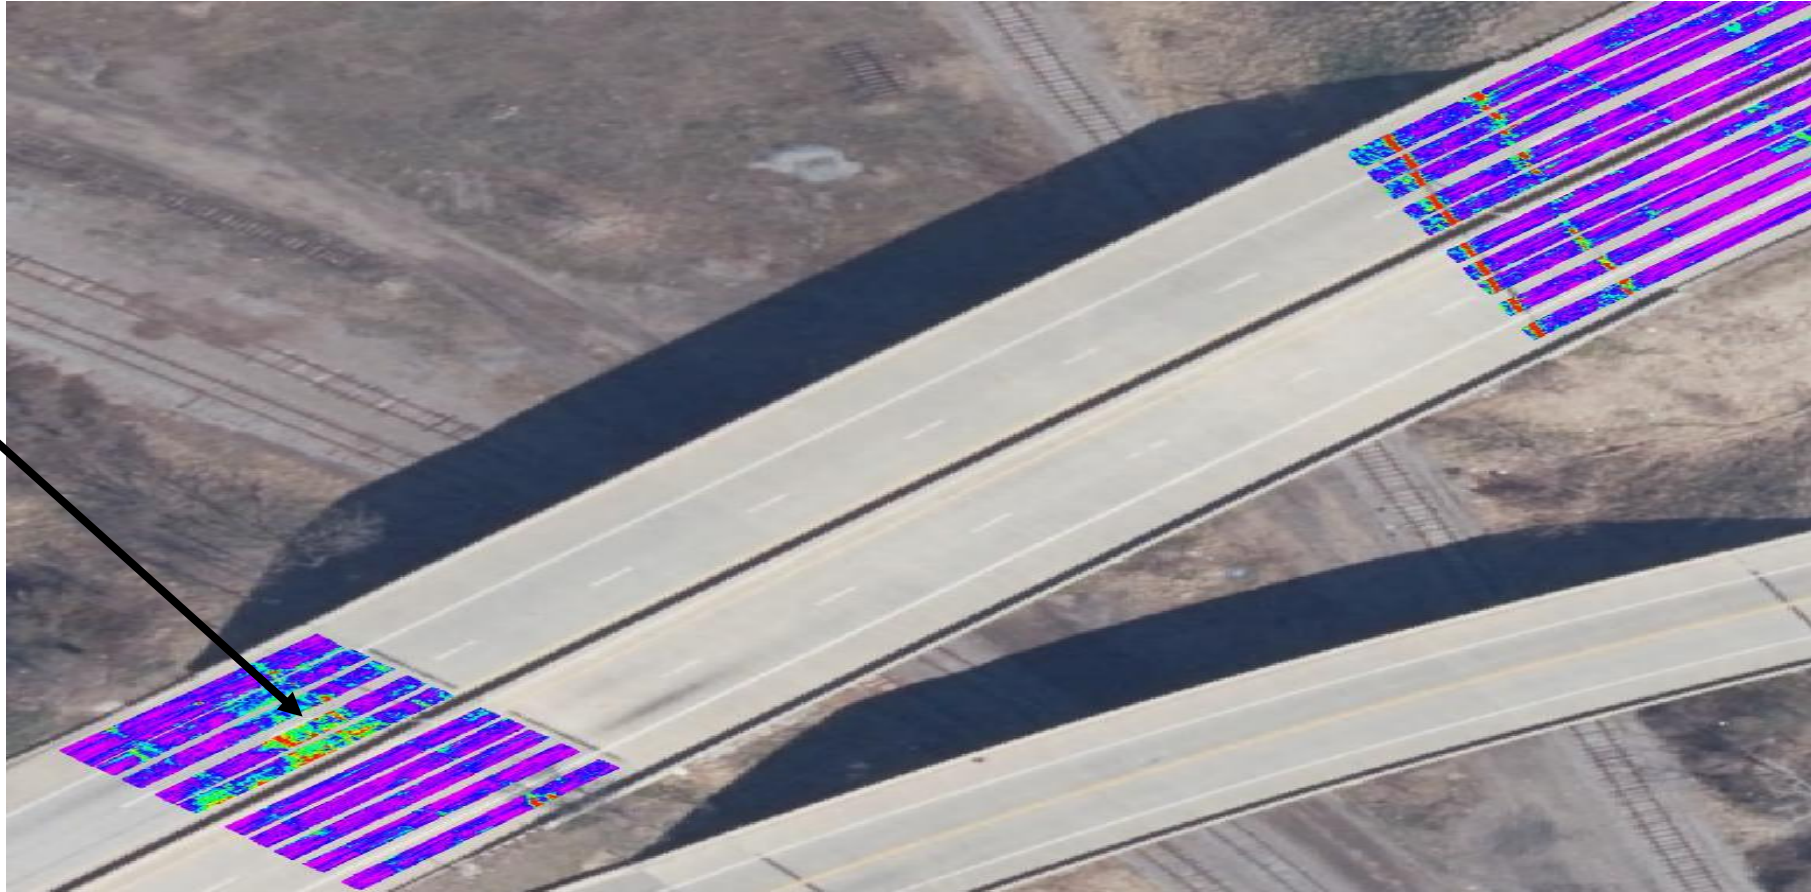
Approach Slab

**Void
Locations**

Repaired with Grout – shallow voids of 1 to 4 inches

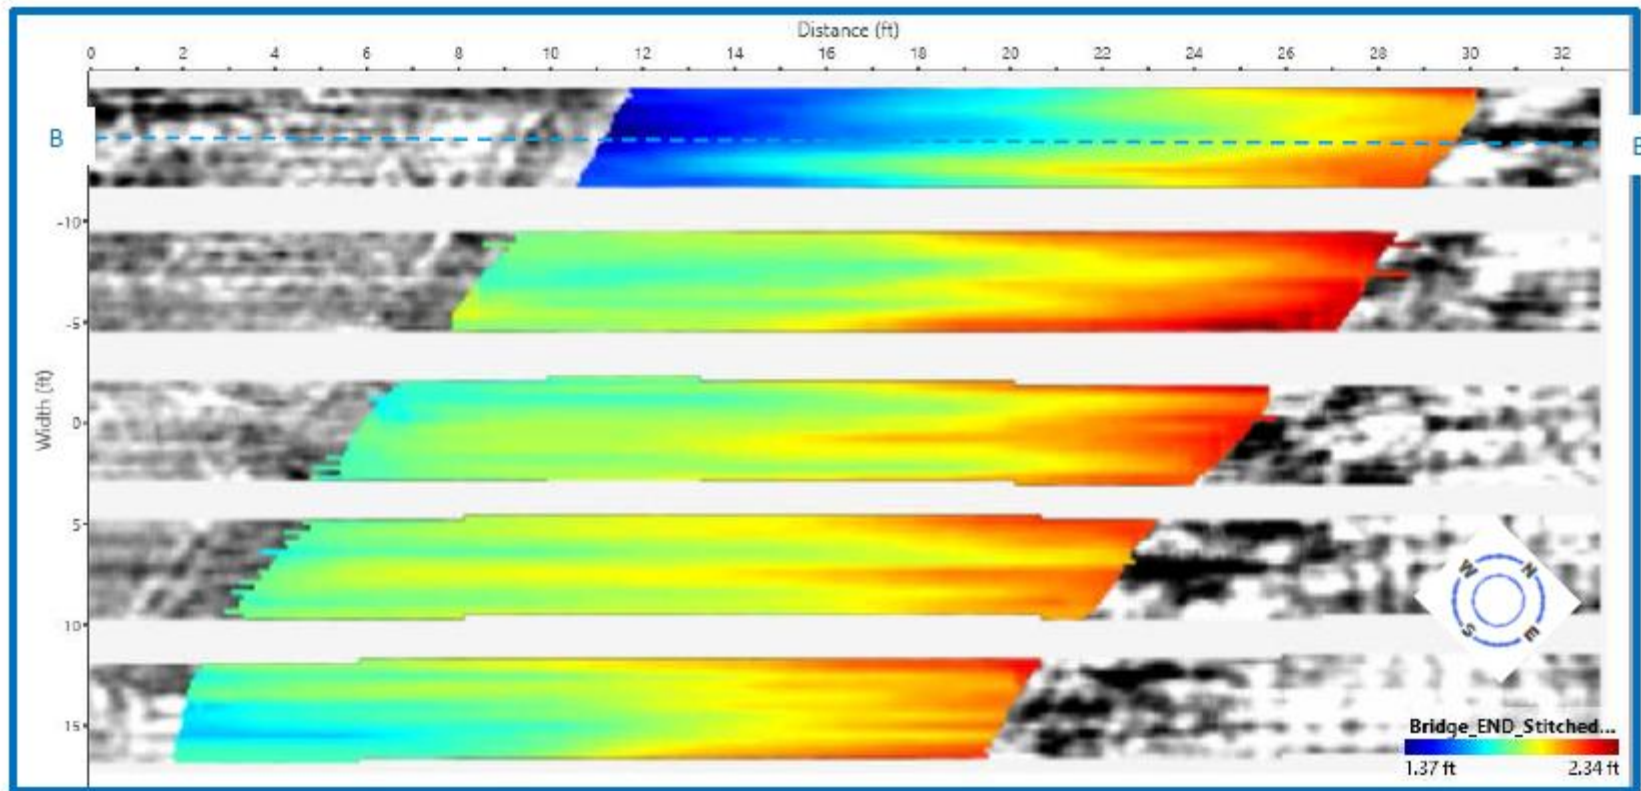
Approach / Exit Slabs

Uneven thickness of Approach Slab

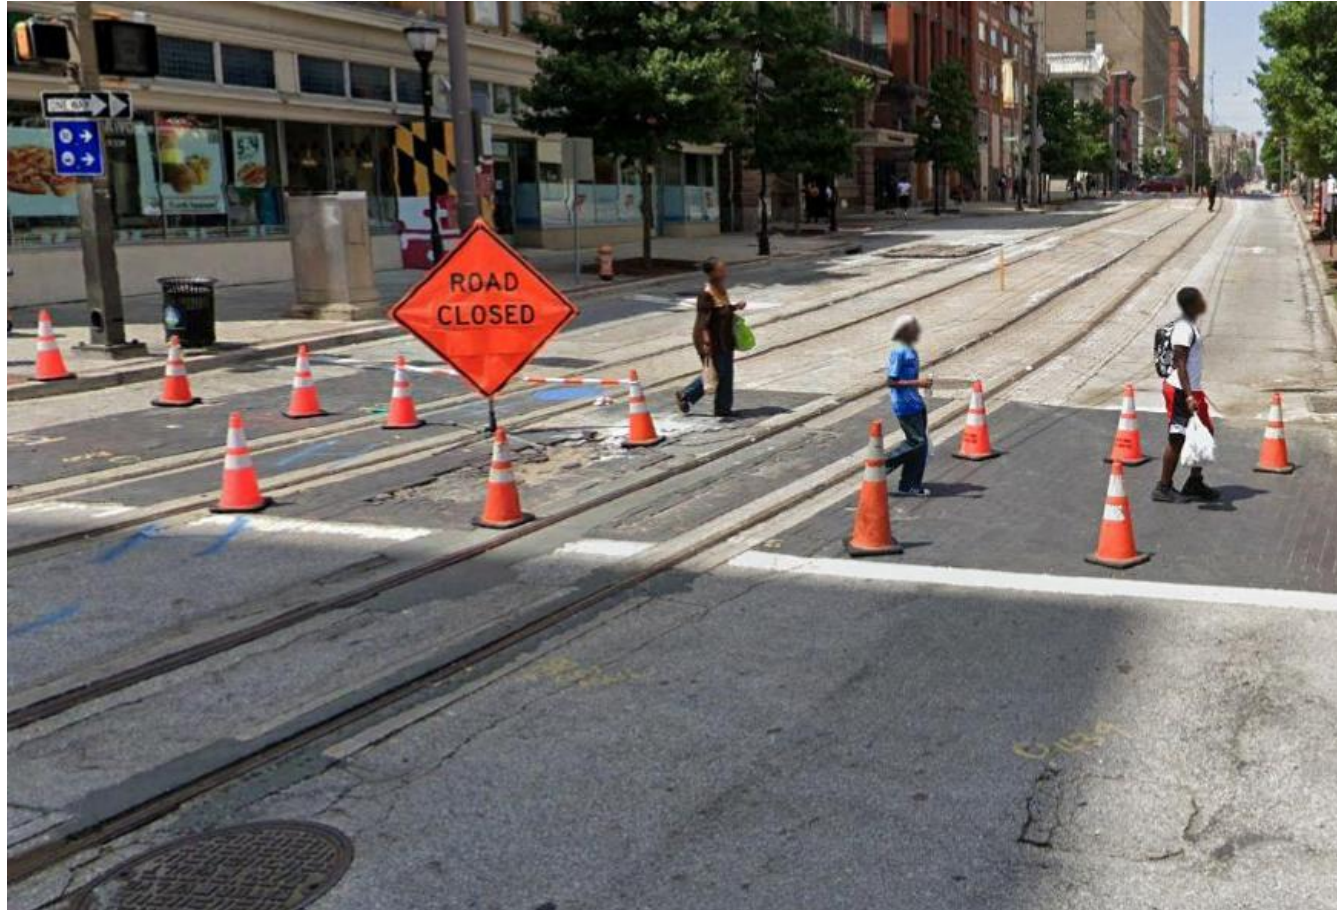
Void LiDAR Measuring Tool

LiDAR Head -- 3 ft depth to head (3 inch core hole required for entry)

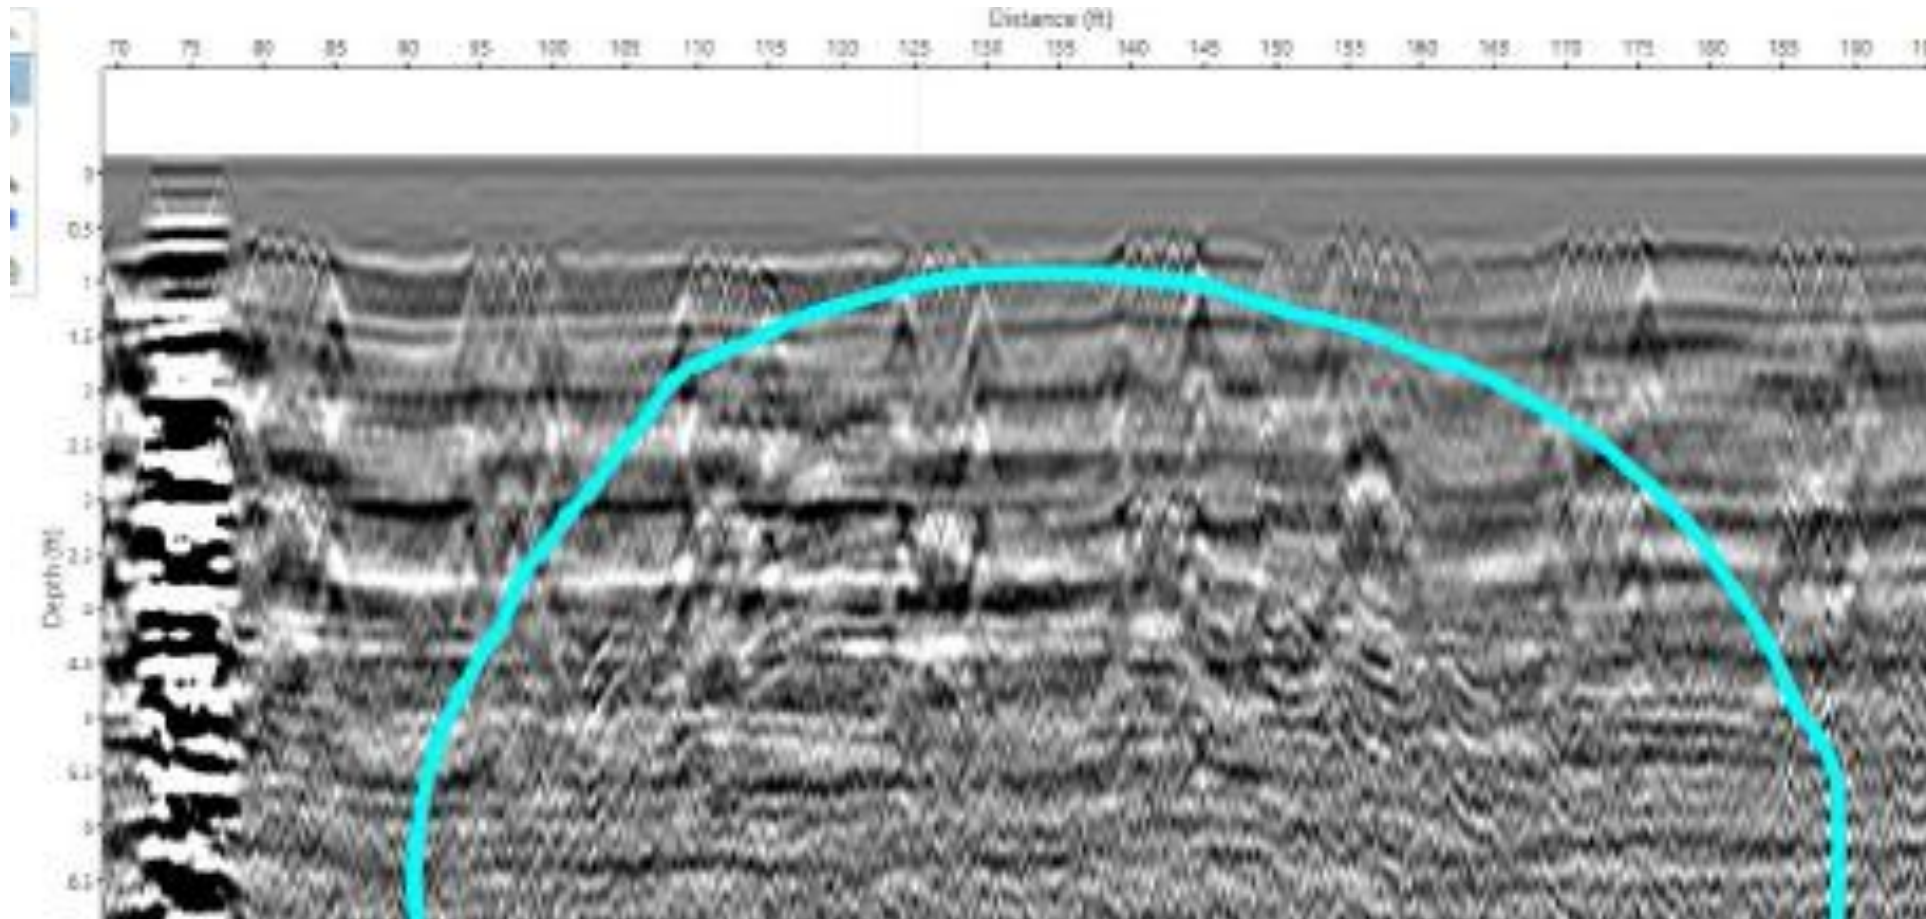
Retaining Structure Investigation - Virginia

Indicate soil raveling below the concrete

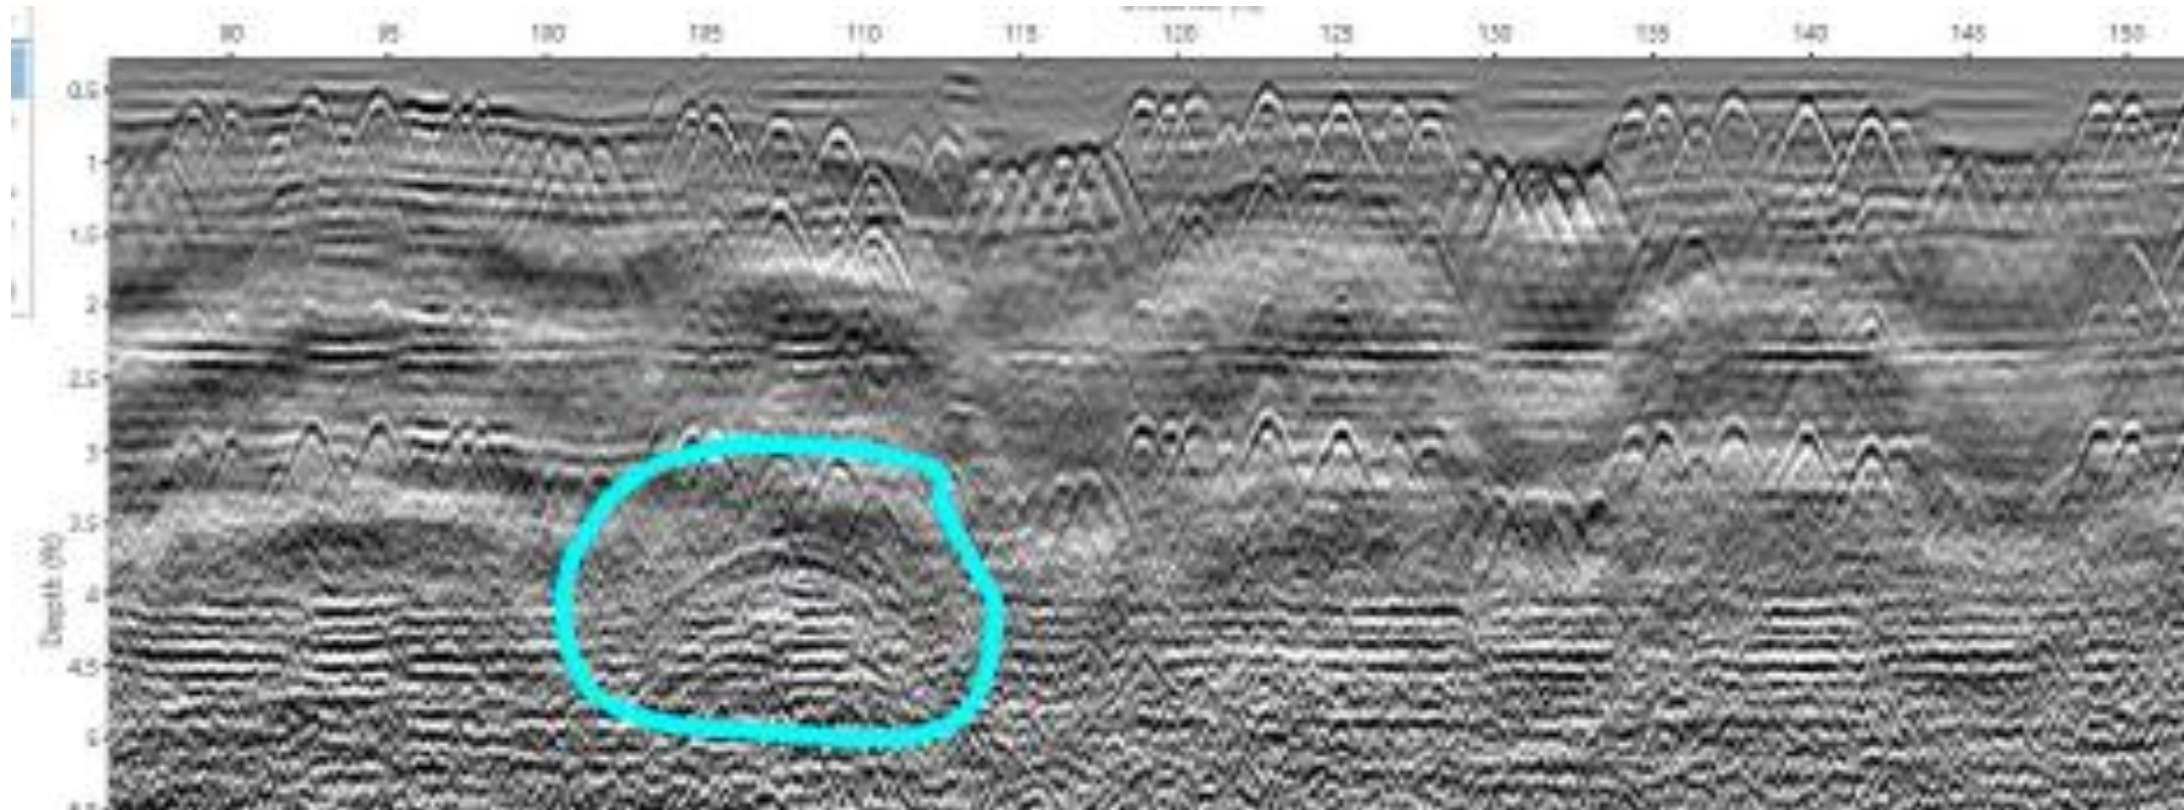
Retaining Structure Investigation

Discrete feature like debris in the fill, void, boulder, etc.

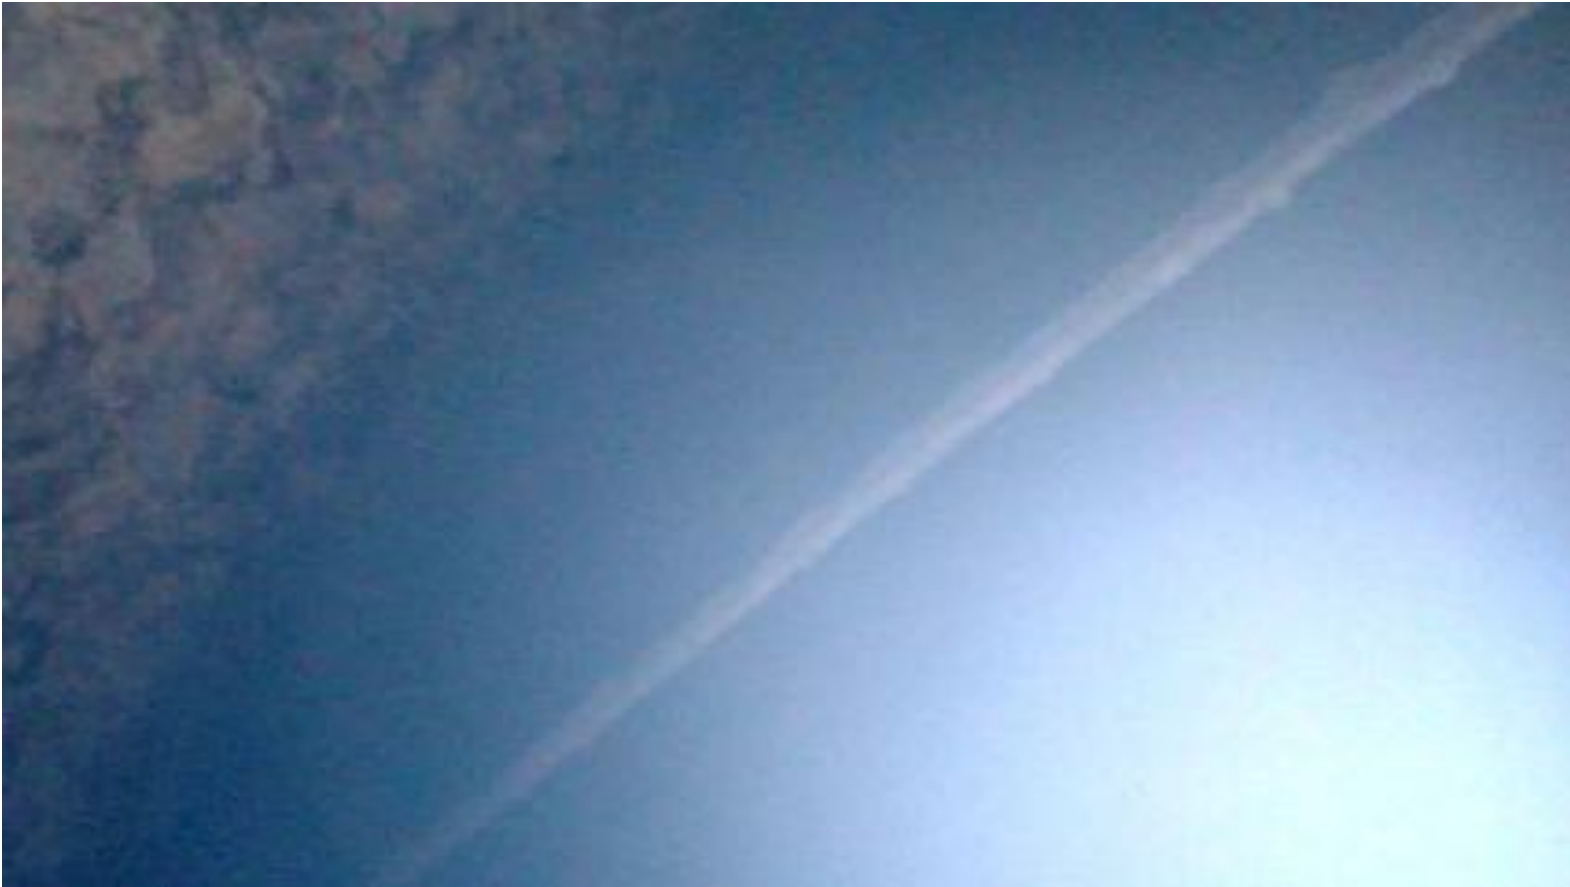
Retaining Structure Investigation - Maryland

MSE wall reinforcing strap
crossing within the void
